Case History

New Trendmaster® 2000 System quickly results in savings

by Marlin Swikert
Electrical and Controls Engineer
Florida Power Corporation, Anclote Plant

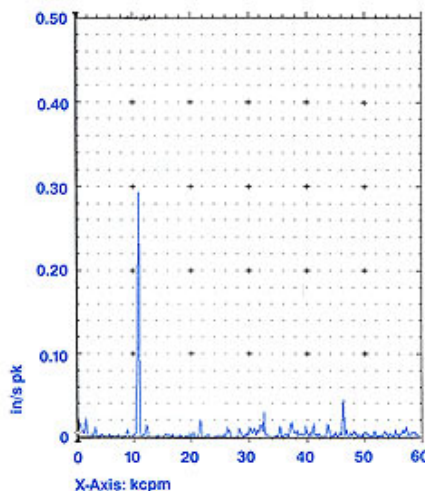
Figure 1
Spectrum Plot of fan 1-1 taken on 28 February indicates a spike at 11,000 cpm.

The initial installation was completed in February 1992 during the plant's annual cooling tower maintenance outage. Data collected from the initial run of the cooling tower fans immediately revealed a problem with fan 1-1. Figure 1 shows the Spectrum plot taken on 28 February. The 0.3 in/sec spike is at

11,000 cpm which is the fundamental gearmesh frequency of the intermediate-output gear. The second and third harmonics are also present. It was suspected that these gears were misaligned, and the gearbox was removed and disassembled. Misalignment was noted and corrected. Figure 2 is the 21 May signature of the same gearbox.

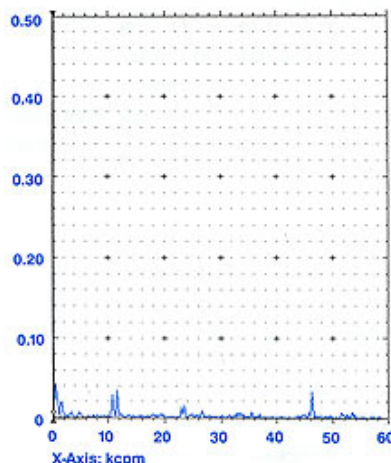
Figure 2
Spectrum Plot of fan 1-1 on 21 May after a misalignment problem was corrected.
